Final Environmental Assessment

13th Street Bridge Emergency Repair and Retrofit

Vandenberg Air Force Base California

23 June 2003

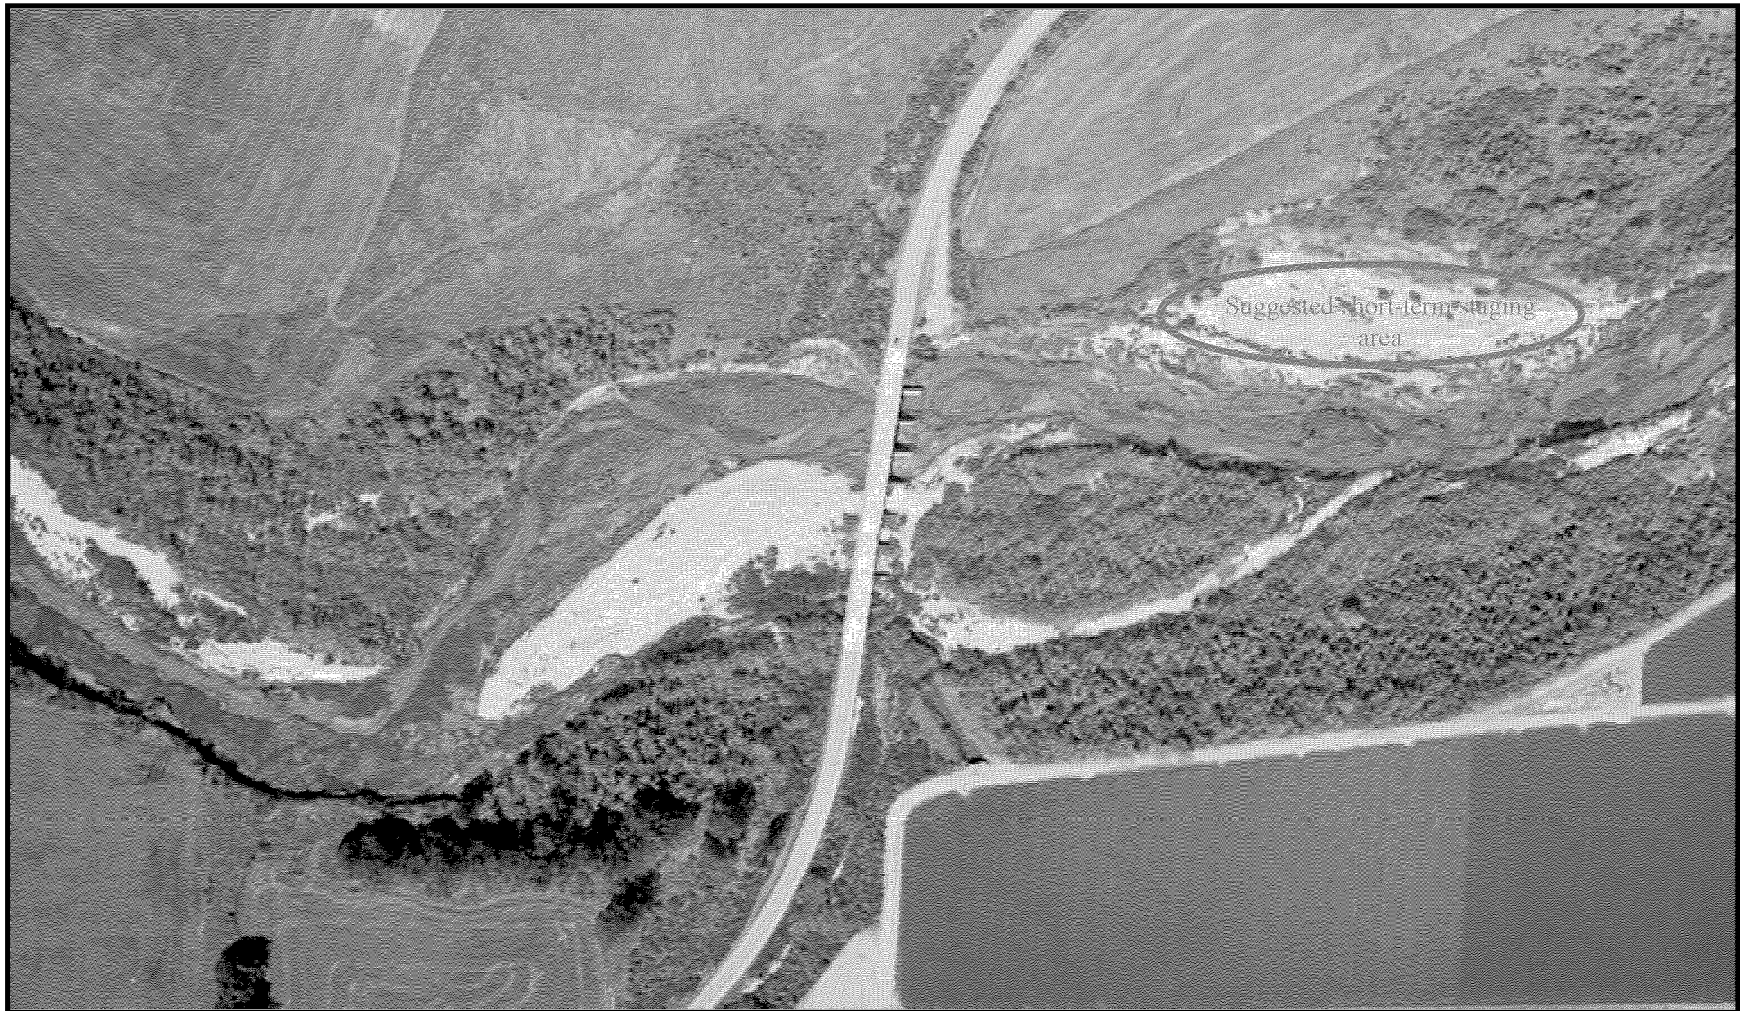
Figure 2-6. Aerial view of 13th Street Bridge vicinity and suggested short-term staging area in upstream unvegetated sandbar for proposed retrofit project.

In addition to the staging areas described under Emergency Repair, additional short-term storage space for temporary staging of materials within the riverbed would be needed during the proposed retrofit. The areas most suitable for this are situated within the existing unvegetated sandbar upstream of the bridge (Figure 2-6). No additional vegetation will be removed to provide access to this area, and grading will not occur. Access to this area will be through the temporary access created parallel to the riverbank and which will span up to 900 feet upstream of the river (Section 2.2.4.1). Construction materials that will be stockpiled in these areas will include shoring and falsework form lumber, erosion control devices, stone aggregates, and tools needed to build and erect

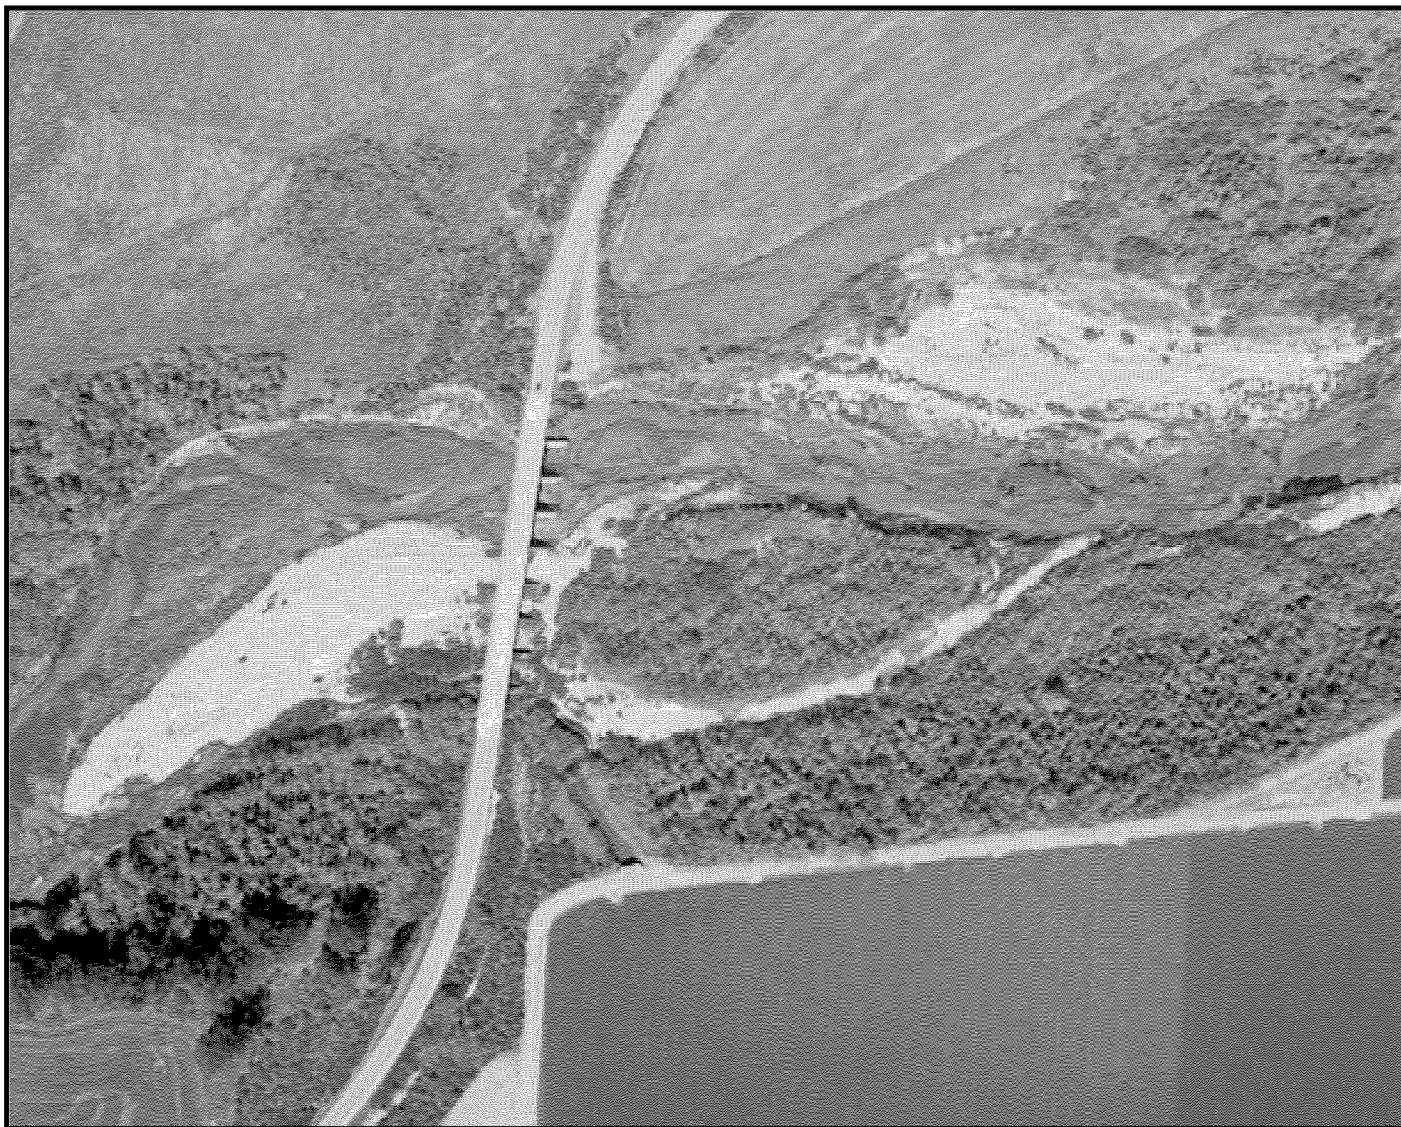
Figure 2. Aerial view of the vicinity of the 13th Street Bridge project area.

The project area is located at the point where 13th Street on Vandenberg AFB crosses the lower reach of the Santa Ynez River, approximately three miles east of the Pacific Ocean (Figure 1). The width of the riverbed at its passage through the project area varies between approximately 500 and 700 feet (Figure 2).
